Docket No. 217 – Development and Management Plan Inspection

Northeast Utilities Service Company Certificate of Environmental Compatibility and Public Need for the construction of a 345-kV electric transmission line and reconstruction of an existing 115-kV electric transmission line between Connecticut Light and Power Company's Plumtree Substation in Bethel, through the towns of Redding, Weston, and Wilton, and to the Norwalk Substation in Norwalk, Connecticut.

Date: July 12, 2006

Location: 115 kV Underground Route

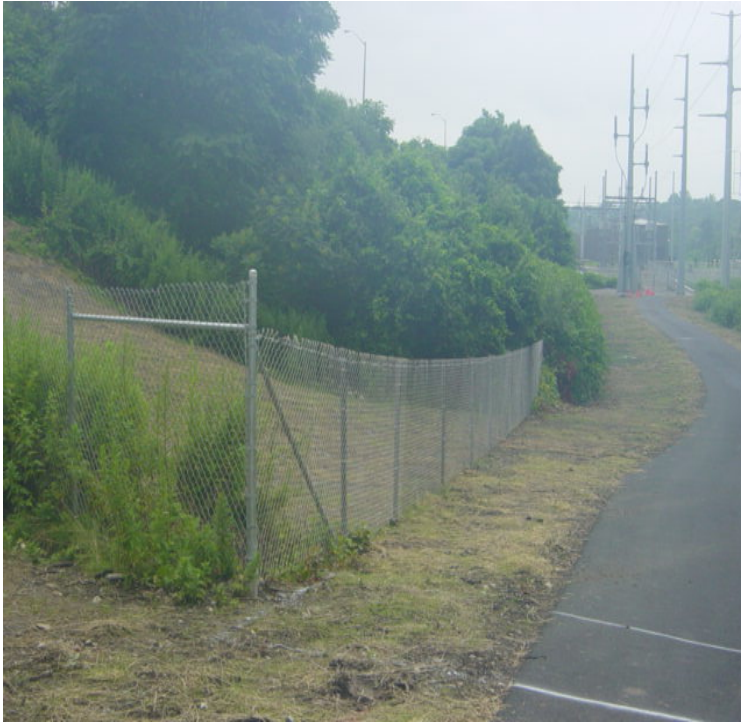
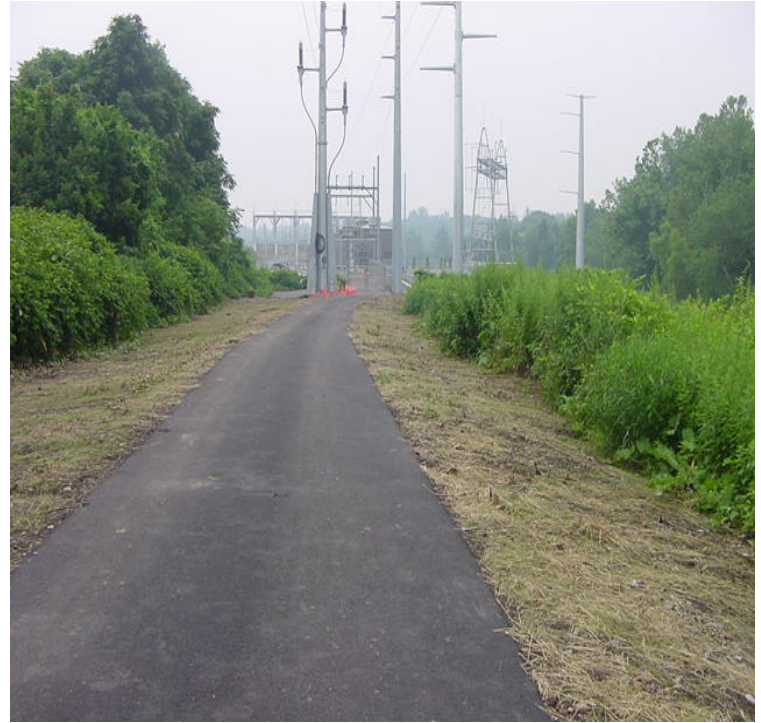
Photo on the left shows the chain link fence installed adjacent to the bike path north of Norwalk Substation off Broad St. Photo on the left shows a broader view of the bike path. Some silt fence debris was noted in and adjacent to the restored area and it should be removed. 7/12/06

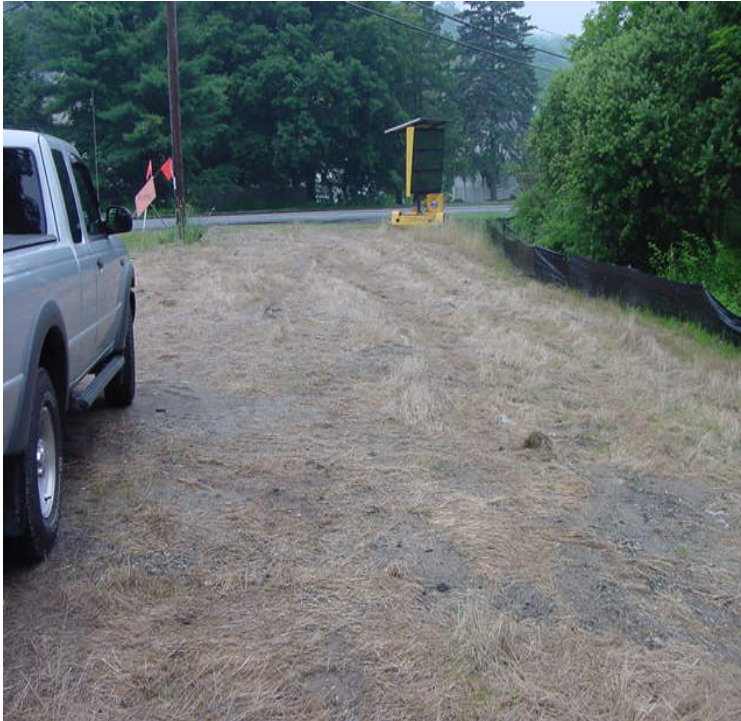
Photo on the left shows a view of the Sunset Hill Rd storage area. The grass had died back but the root system should be able to hold soil in place. Photo on the right shows the washout area along the slope near the southern tower at the Bethel Ed. Park ROW. 7/12/06
